REPUBLIC OF TURKEY
Prime Ministry
Disaster And Emergency Management Presidency,
Earthquake Department, Ankara – TURKEY

REPORT ON VAN EARTHQUAKE
(EASTERN TURKEY)
(MI=6.7 Mw=7.0)

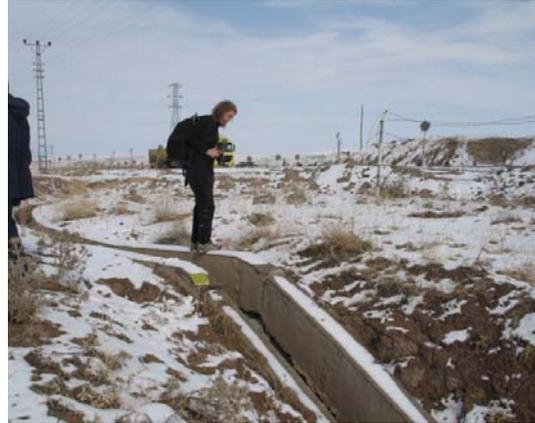
Figure 7.2: Deformation that is observed on the Van-Erciş Highway

Earthquake did not caused any apparent faulting on the surface however some deformation trace is observed on the man-made structures such as irrigation channels, asphalt roads depends on the NW compression (Fig.7.1-7.5).

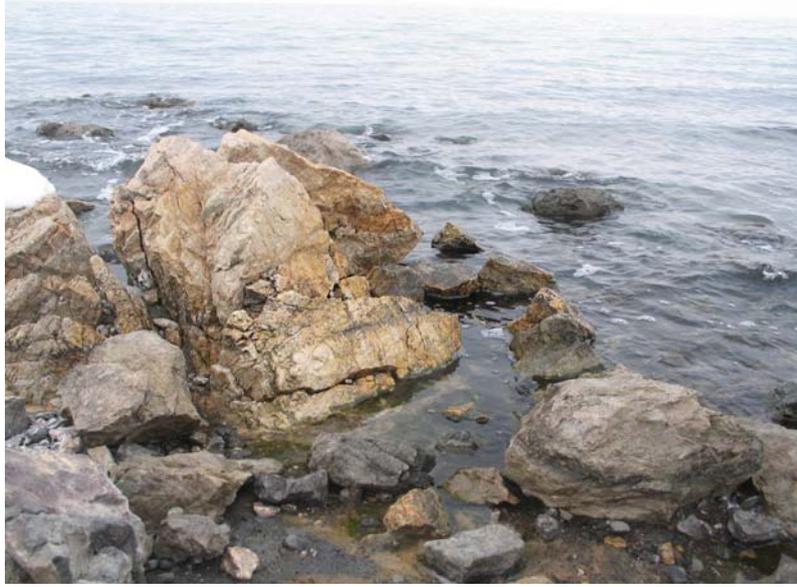
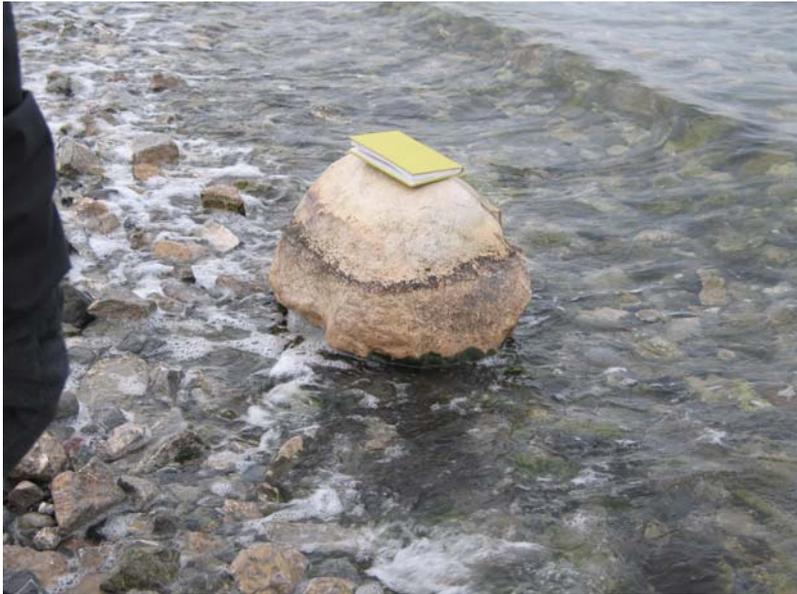
Figure 8.2: Photos about traces of algae on the limestone (west cost of Erçek Lake)

It was seen displacement that occurred after the earthquake on the interferogram that was produced by NASA according to COSMO Skymed image which was taken from Italy Space Agency between 10-26 September (Fig.8.1). It is projected on the interferogram, as a topographic maximum 80 cm rise in the north part of fault and between 5-40 cm rise in the west part of Erçek Lake. Based on this information, some traces were investigated which signified on the interferogram however level change did not observe lake level and rocks which is near the lakeshore (Fig.8.2).

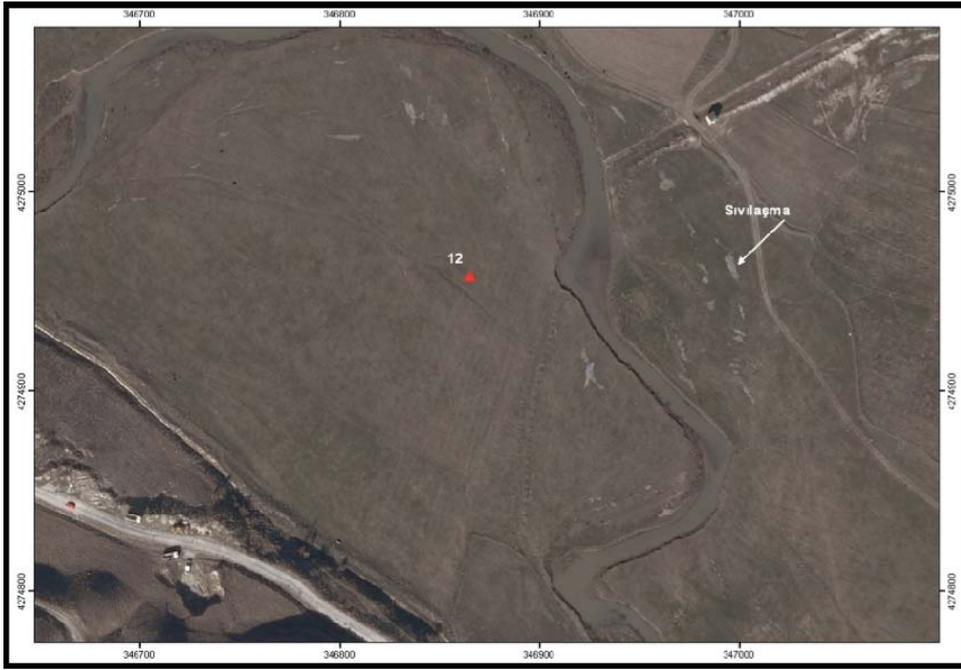
Figure 9.2: Liquefaction between Arısu-Topaktaş villages (Orthophoto image produced by General Command of Mapping)

After the earthquake it was observed landslip, rock fall, liquefaction and lateral spreading in the study area (Fig.9.1-9.3).

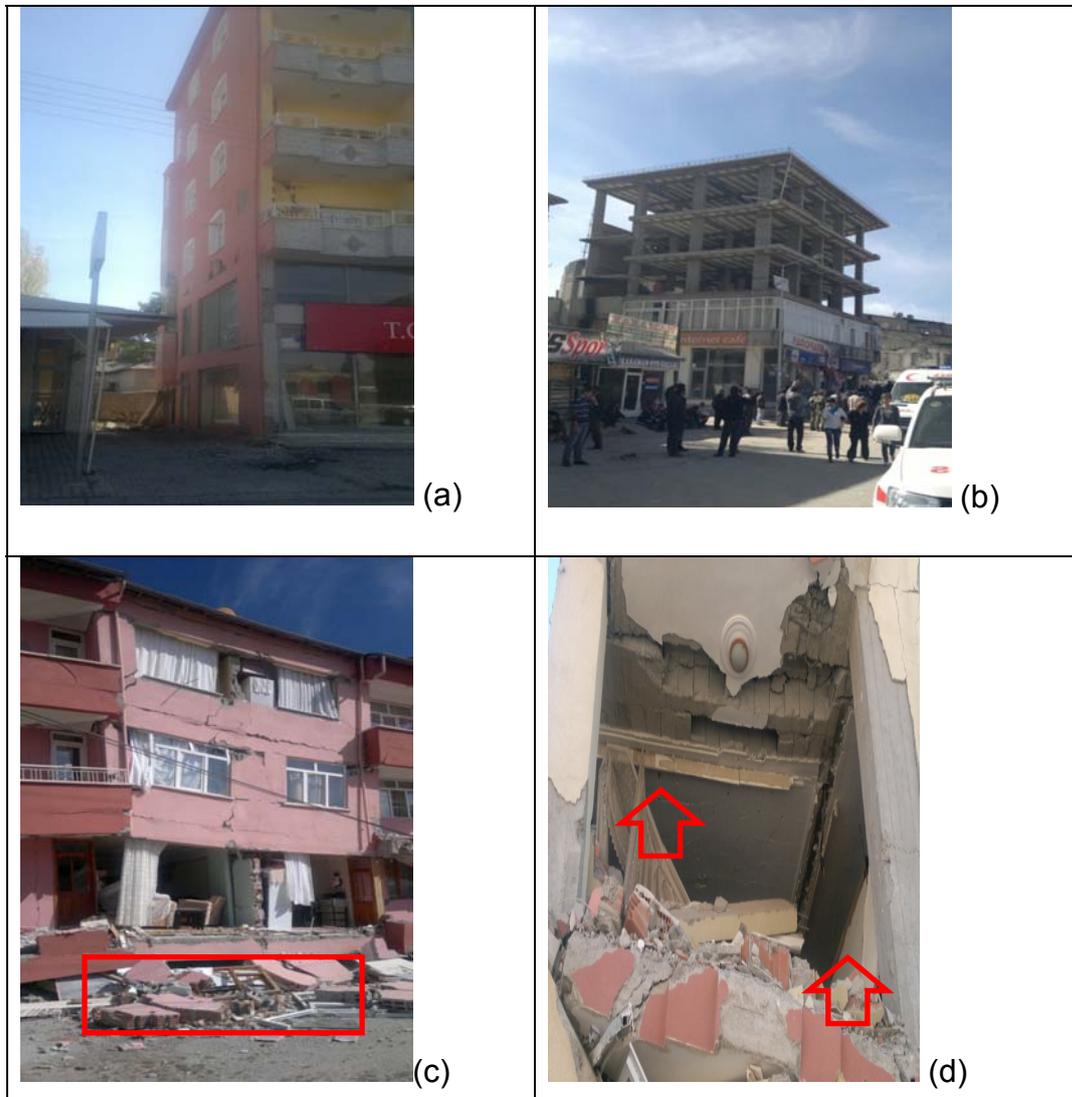
Figure 17.1: Examples of weak storey and slab effect. (a. Weak storey, b. Weak storey and asmlen slab, c. Ground floor destroyed. d. Heavy slab)

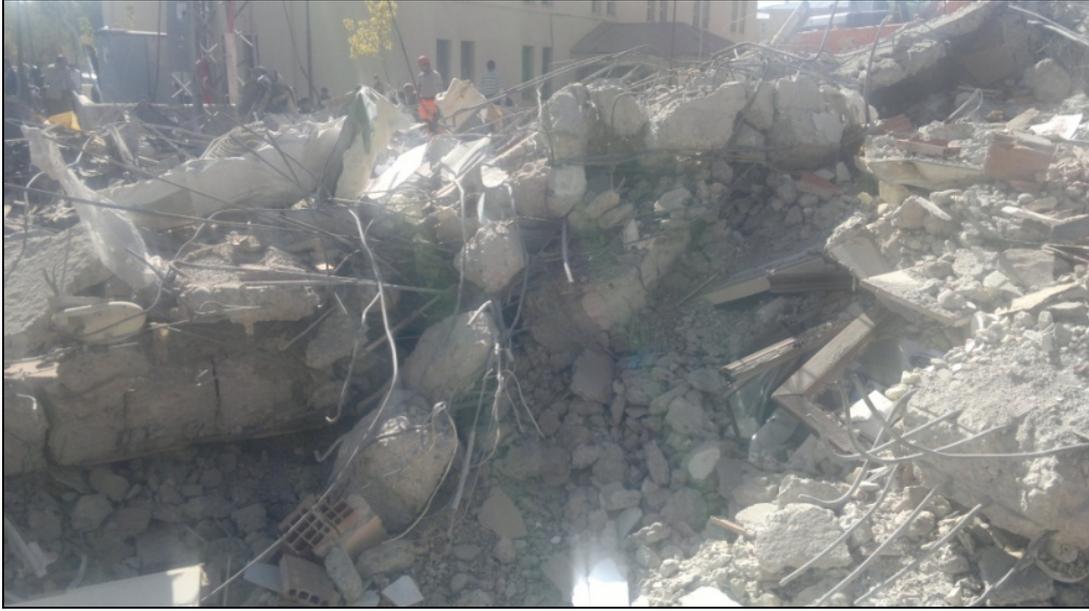
Figure 17.2: Crumbly concrete example

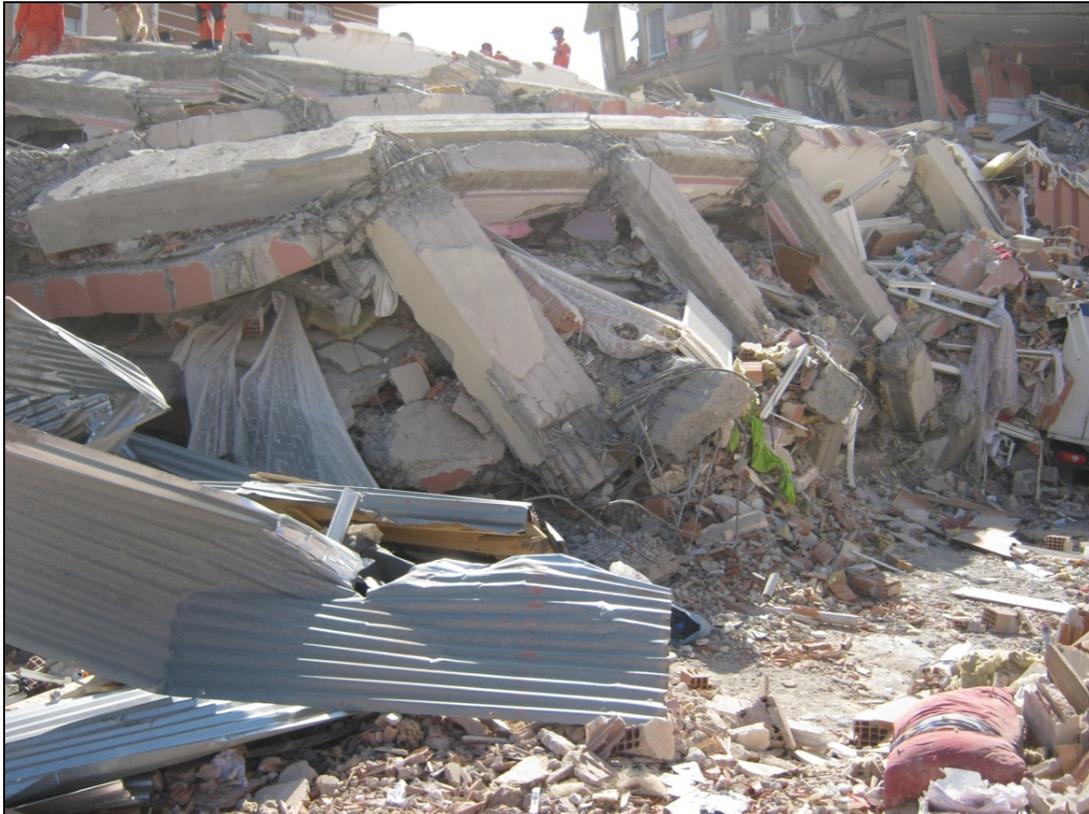
Figure 17.3: Crumbly concrete example

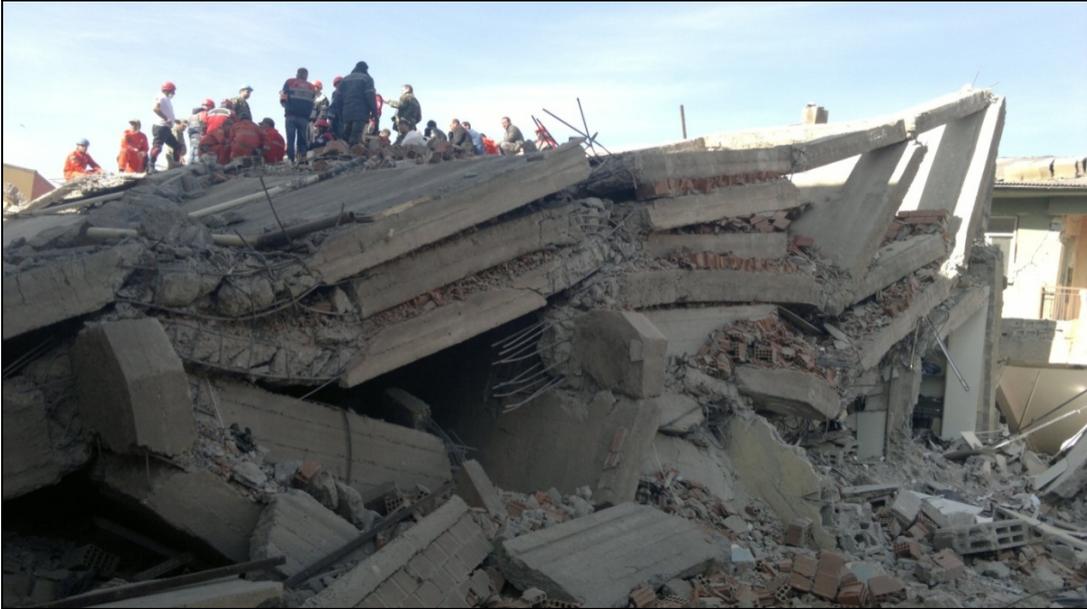
Figure 17.4: Weak storey example

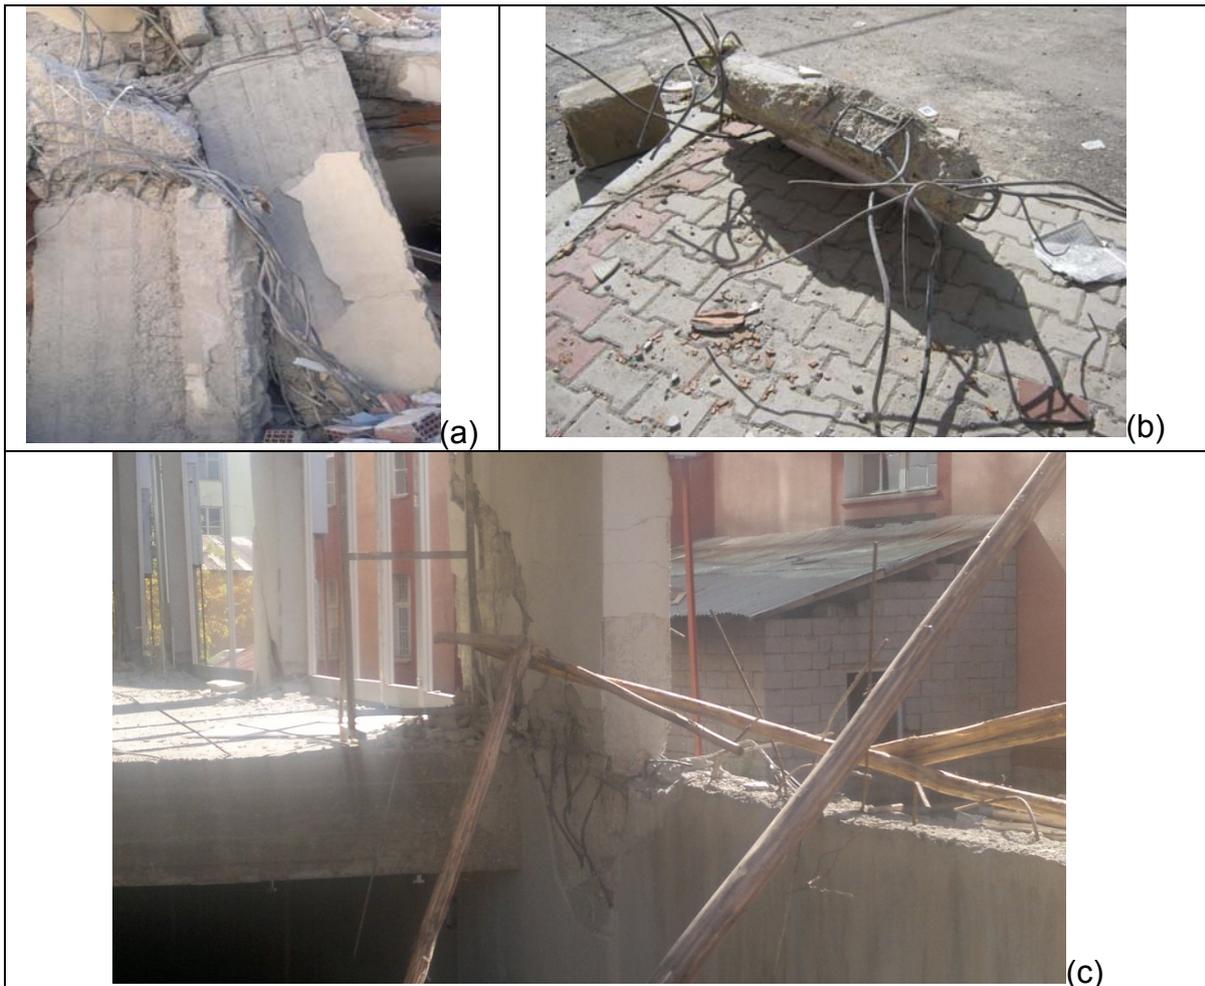
Figure 17.5: a) Striped reinforcement , b) Striped reinforcement
c) insufficient stirrup and shell concrete.

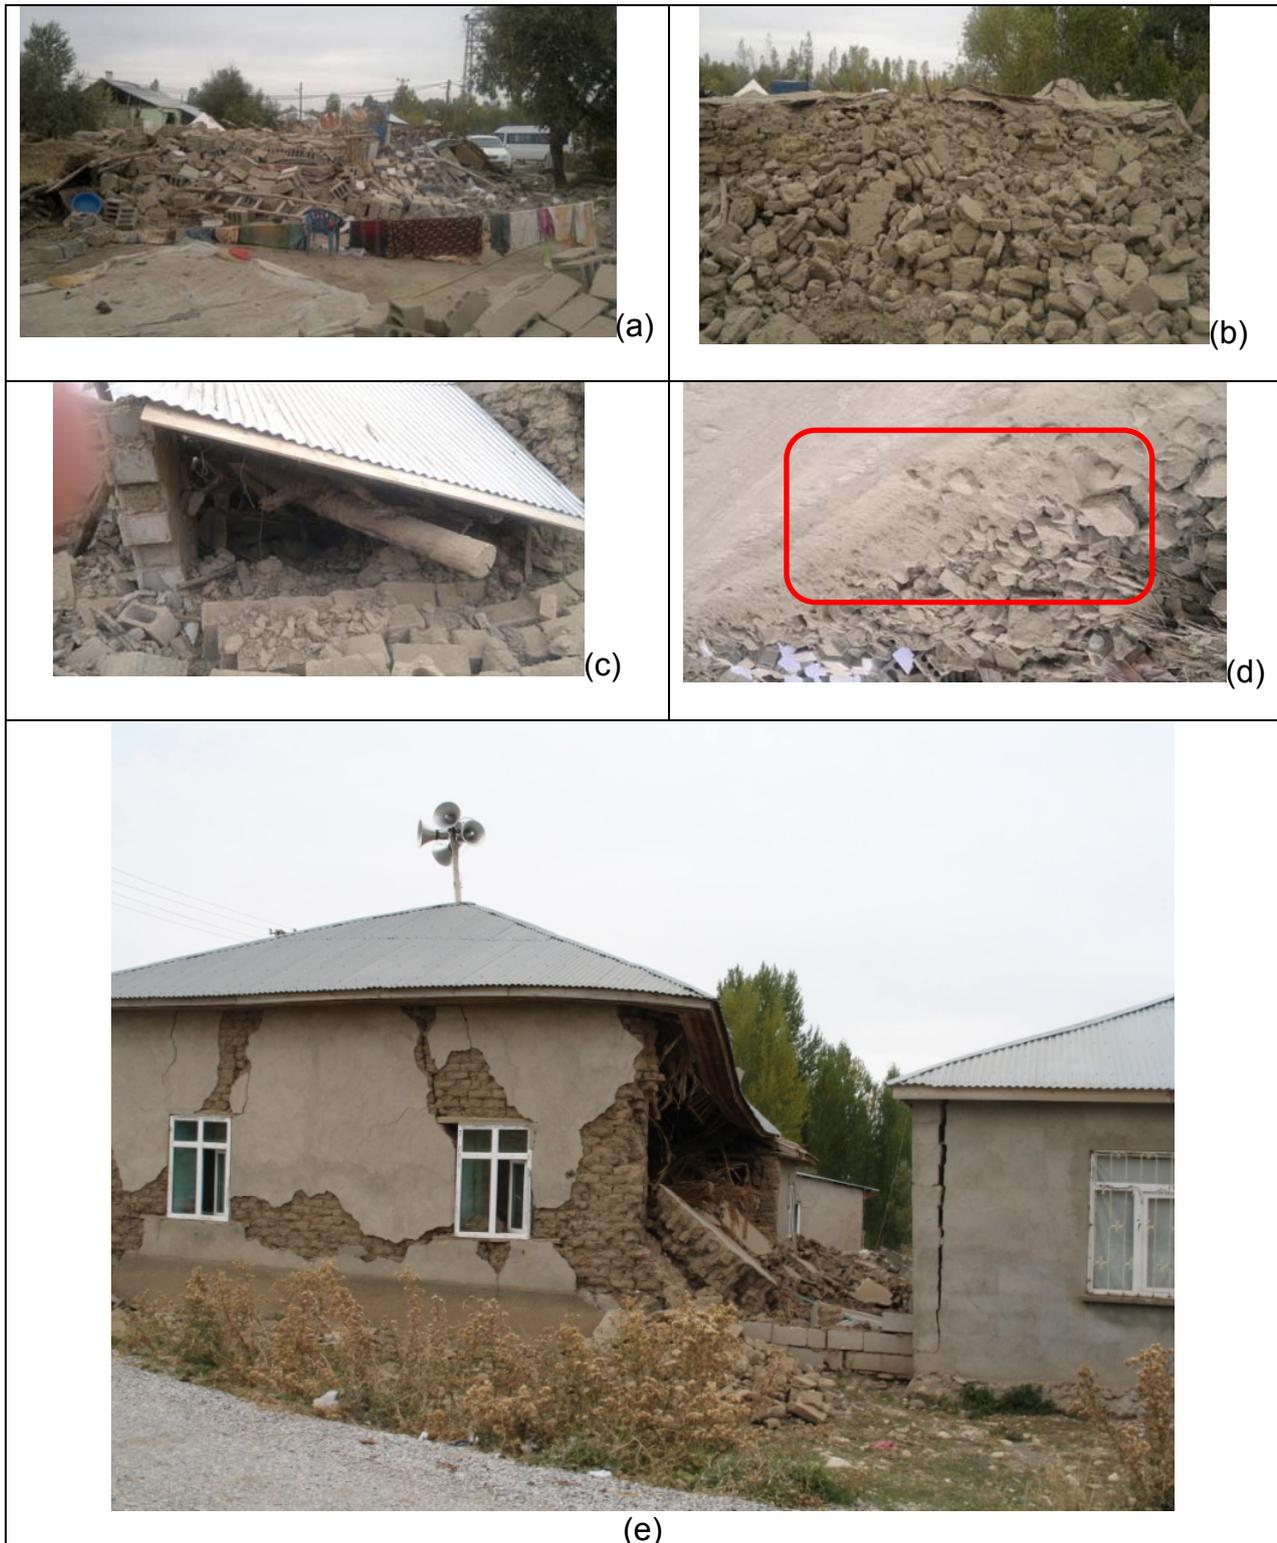
Figure 17.6: a) Briquet filled collapsed building, b) Adobe filled collapsed building
c) Adobe+briquet filled collapsed building, d) Fine grained binding material (cat
litter) e) Collapse to corner join .

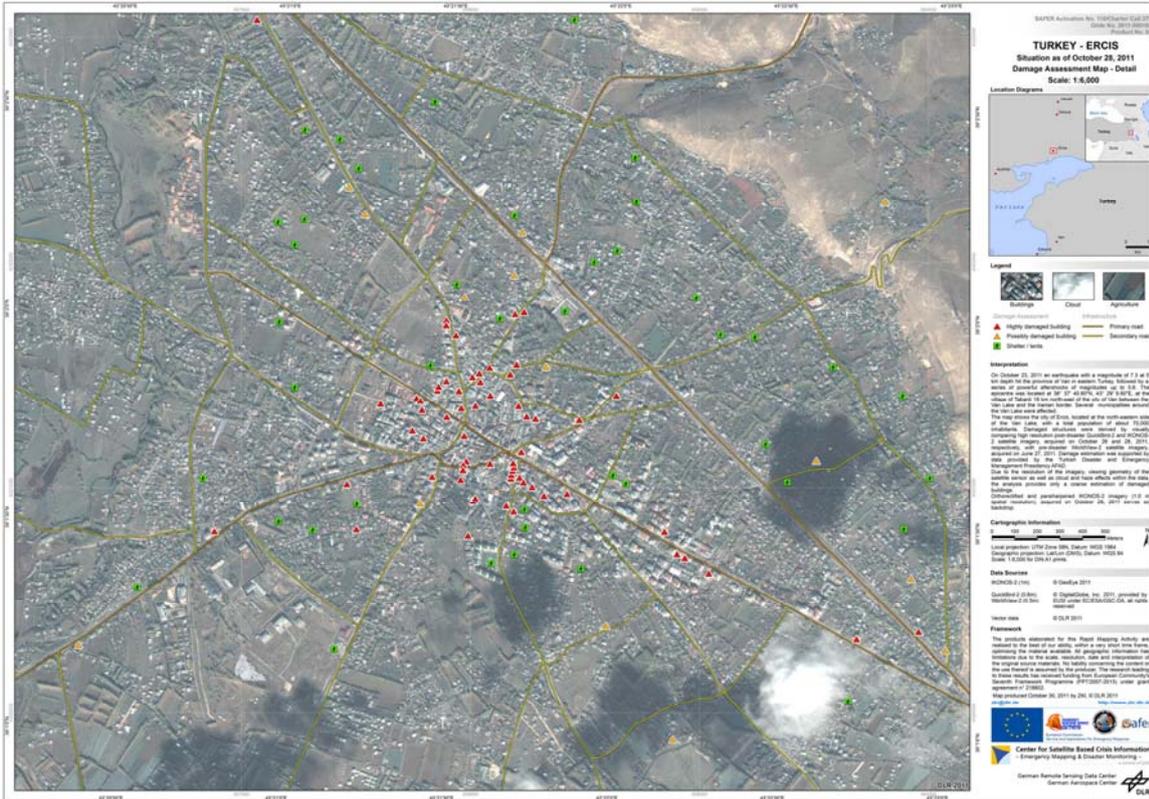
Figure 19.4: QuickBird-2, Iconos images after the earthquake (Erciş) (red triangles show a heavy damage collapse building, yellow triangles show a potential damage building and green polygons show a tent city).
